CAD -269- DEPARTMENT OF ENVIRONMENT AND NATURAL RESOURCES - REGION III

DESIGNATION: BLLM No.191

CONTROL POINT

Bureau of Lands Location Monument (BLLM)

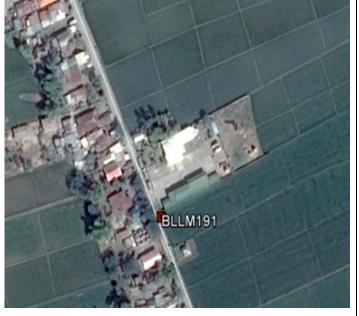
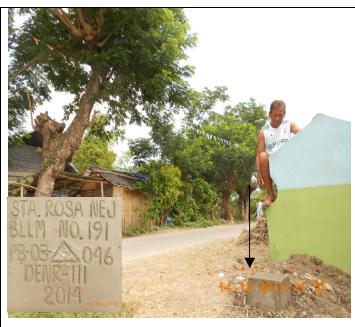
PHOTO / SKETCH

Mark is the head of a 3" copper nail embedded and centered on a 25X 25cm (top) by 35X35cm(base) by 120cm(height) standard concrete square base frustum, set on the ground with protruding 20 cm on the surface with inscriptions..."STA.ROSA NEJ BLLM NO.191, PB-03-000046 DENR III 2014".

The monument is located along the right side of the barangay road beside a concrete wall of a private warehouse. It is 230 meters after the Barangay Hall of San Isidro.
